Effects of Ecohydraulic Bank Stabilization Structures on Bank Stability and Macroinvertebrate Community in Surabaya River

There were 18 accelerated erosion sites identified along 7 km of Surabaya River Fishery Sanctuary Area. A model of ecohydraulic bank stabilization was applied to reduce bank erosion in Surabaya River at Gresik Regency Indonesia. The model is combination of reprofiled and revegetated bank with rock toe reinforcement [1] and addition of log groynes [2]. Various native plant species were planted and naturally grown to establish multi-strata littoral vegetation structure. This study assessed effects of ecohydraulic bank stabilization on bank morphology, near bank velocity and littoral macroinvertebrate community during September 2014 to August 2016. The study found that rock toe enforcement, log groynes and reprofiled bank slope could stabilize the eroded bank, and littoral vegetation formation reduced near bank velocity at restored sites. There were 31 families of macroinvertebrate found in Surabaya River with high abundance of moderately pollution sensitive taxa Atyidae and pollution tolerant taxa Corixidae, Chironomidae and Tubificidae. The taxa richness, divers

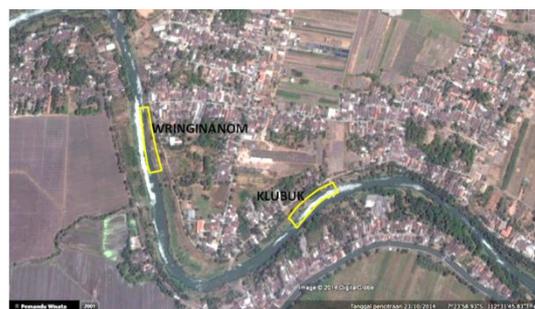
Figure 2. Application sites of ecohydraulic bank protection in Surabaya River Fishery Sanctuary

The study area was located along 7 km of Surabaya River from Mlirip Mojokerto to Legundi Gresik that has been managed as Riverine Fishery Sanctuary Area since 2014. The map of study sites in Surabaya River Fishery Sanctuary at Brantas Basin is shown in Figure 1. The application sites of ecohydraulic structure is shown in Figure 2.

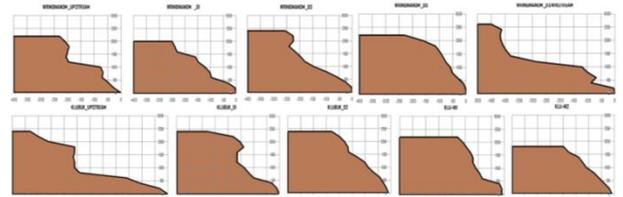
Figure 4 . Morphology of eroded bank before application of ecohydraulic bank stabilization model in Wringinanom and Klubuk

The boat survey along 7 km of Surabaya River Fishery Sanctuary Area was carried out during low flow in July 2014. There were 18 accelerated eroded sites identified along 7 km section from Mlirip to Lebaniwaras. The length of eroded bank range from 50 m to 400 m, and the bank height range from 1,5 m to 4 m. The riverbank along Surabaya River is bordered with dykes and marked with riverbank points that can still be found on the dyke edges. Some native riparian vegetation species can be seen on the banks, such as variety of bamboo and grasses, shrubs, liana,herbs, and tree species. Most of the riverbanks were used for agriculture to grow corn, rice, cassava, chili and vegetables. However, in some area there were permanent houses, small factories and impermeable roads build on the riverbanks that could impair its function as floodplain area, sediment trap and wildlife habitat. The condition of bank erosion is shown in Figure 3, and the bank morphology profile at pre-restored sites is shown in Figure 4.

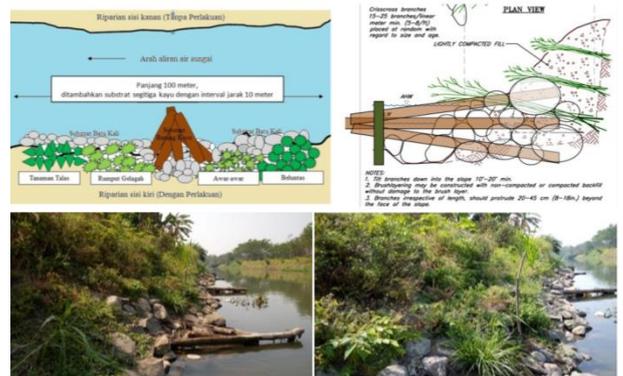
Figure 5. Design of ecohydraulic bank stabilization model in Wringinanom and Klubuk (top); Ecohydraulic Bank stabilization structure during low flow after 6 months of application (bottom)

The design of ecohydraulic bank stabilization model and the condition of bank morphology at post-restored sites is shown in Figure 5.

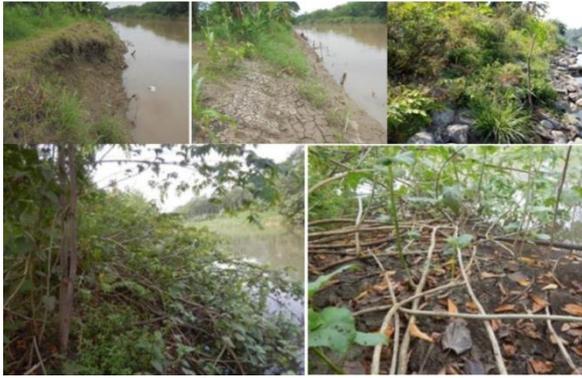
Figure 6. Change of eroded bank morphology at application sites in Wringinanom. Top left: before restoration, middle: during high flow, right: during low flow. Bottom: riparian vegetation cover after 1 year of restoration provide protection against erosion and create new macro-habitats

Bankslope at Post-Restored sites become less steep due to bank reprofiling in application of ecohydraulic bank stabilization structure. The bankslope at Pre-Restored sites range was more than 45 degree, while bankslope at Post-Restored sited decreased to less than 40 degree. The changes of eroded bank condition after application of ecohydraulic bank stabilization models is shown in Figure 6. The rock toe reinforcement protects river bank base from near bed current, while the log spur triangles and littoral vegetation slowed down the near bank velocity during high flow that stabilize the eroded bank and provide new micro-habitat for river biota.

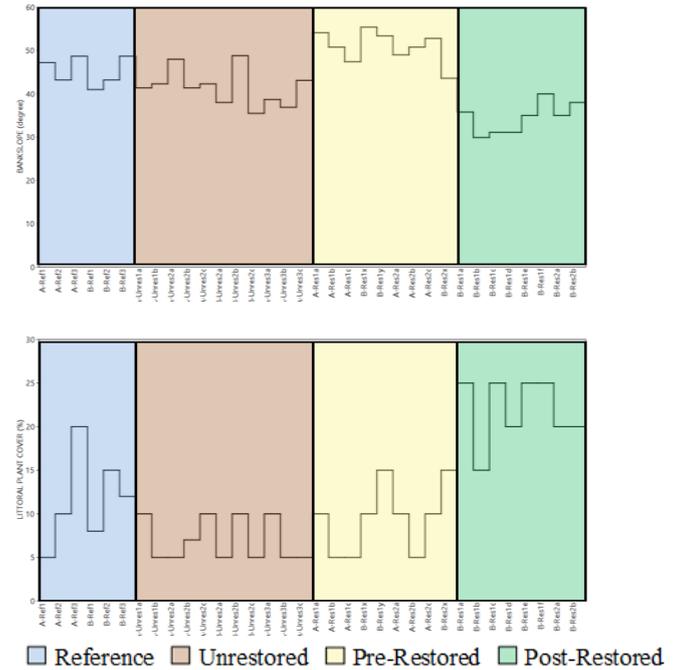
The results of field survey on bankslope and percentage of littoral plant cover in Surabaya River Fishery Sanctuary Area are shown as step graph in Figure 7. The bank morphology graph shown that bank slope degree at eroded sites decreased significantly and became less steep after application of ecohydraulic bank stabilization structure. The near bank velocity at post-restored sites significantly lower than both pre-restored and unrestored sites, as shown by Mann Whitney pairwise test results. The rock to enforcement and reprofiled bank slope stabilized the eroded bank. The ecohydraulic bank stabilization model succeed to maintain bank steepness to less than 40 degrees and rock toe reinforcement at bank base reduced the near bank current velocity that reduce bank erosion at restored sites. The percentage of littoral plant cover increased significantly at post-restored sites compared to pre-restored and unrestored sites. Tree species that grow well in the treatment sites that can cope with drought and floods in the floodplain area are *Ipomoea aquatica*, *Ficus glomerata*, *Bambusa sp.*, *Ficus benjamina*, *Hibiscus tiliaceus*, *Psidium guajava* dan *Mangifera indica*.

Figure 7. Bankslope and % littoral plant cover in Surabaya River Fishery Sanctuary Area

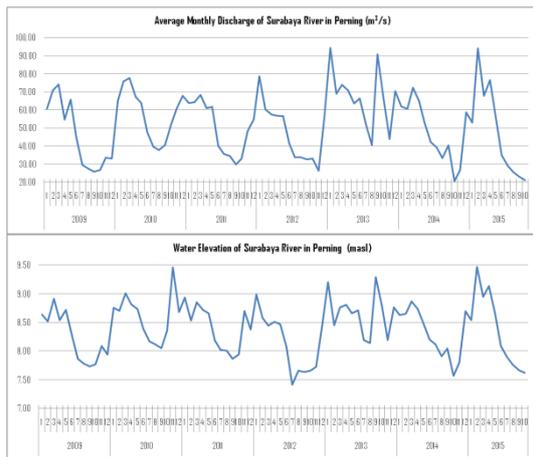
The hydrograph of Surabaya River in Perning station during 2009 - 2015 shown that wet season period occurs in December to May, while dry season period occurs in June to November (Fig.8). The highest discharge of Surabaya River in Perning was 94,2 m³/s in Januari 2013 while the lowest discharge was 20,6 m³/s in October 2014. The discharge of Surabaya River is controlled by water sluice in Mlirip that control water intake to Surabaya River by diverting excess discharge from Brantas River into Porong River and Mangetan Canal. However, Surabaya River receives uncontrolled flow from Marmoyo River. The highest water elevation of Surababaya River in Perning Station was 9,5 meter above sea level in February 2015, while the lowest water elevation was 7,4 meter above sea level in July 2012, that the maximum seasonal water elevation difference was 2,1 meter that indicated the flood height in Surabaya River. Riverbank on left and right side of river channel need to be protected as flood retention zone that should be free from permanent impermeable structures to prevent more flood discharge to downstream area, to reduce sediment and pollutant loads into downstream estuarine waters.

Figure 8. Average monthly discharge and water elevation of Surabaya River in Perring Station during 2009-2015 (Data Source: Perum Jasa Tirta I)

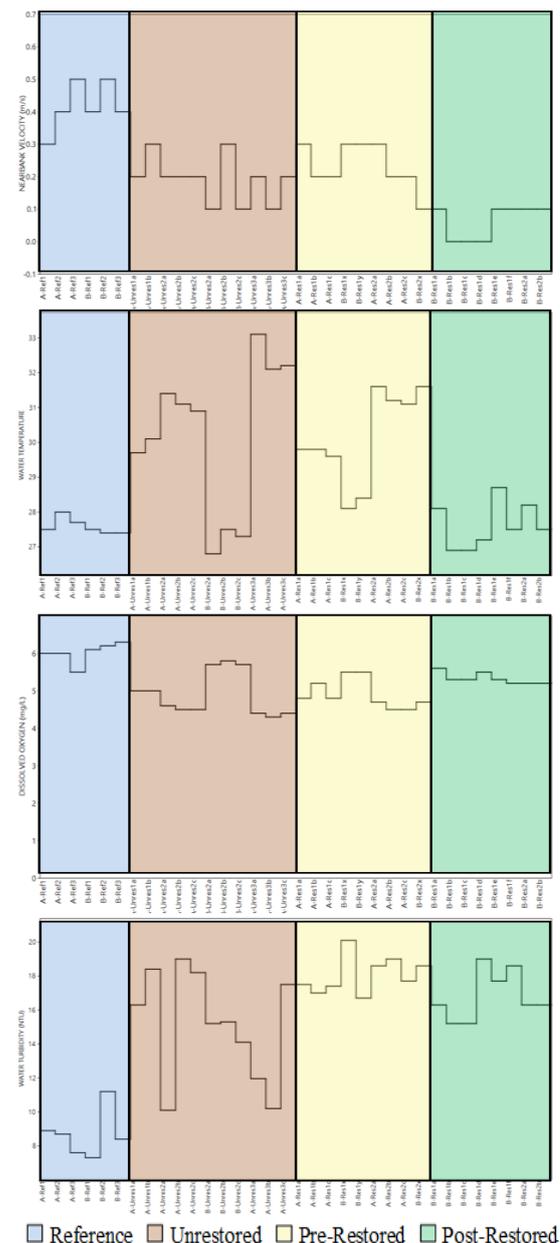
Figure 9. The steps graph of near bank velocity and water quality of Surabaya River

The Mann Whitney Pairwise Test at 95% confidence shown that near-bank velocity at post-restored sites decreased significantly compare to unrestored and pre-restored sites. The ecohydraulic bank stabilization structures effectively reduce velocity near bank base and littoral river bank that reduced bank erosion and improve bank stability at restored sites. The water temperature at post-restored sites significantly different with those at unrestored and pre-restored sites. The lower temperature was due to increase of vegetation cover in littoral water and increase of shade from multi-strata vegetation on higher riverbanks. The results of hydraulic variables measured, i.e. near bank velocity and water quality parameters were shown as step graph in Figure 9.

The dissolved oxygen at post-restored sites significantly different with those at pre-restored sites. This was caused by turbulence created by rock toe reinforcement at the bank base, log spur dykes and littoral vegetation along the restored banks. The materials also provide new habitat for algae and moses to grow that increase oxygen release into water through photosynthesis by water plants grown in littoral zone. The water turbidity at post-restored sites was not different significantly with those at unrestored and pre-restored sites. The water turbidity was caused by high sediment loads from upstream area due to forest degradation and land use change in the upper drainage area that could not be reduced by ecohydraulic bank stabilization at limited area with vegetation cover in littoral waters and riverbanks along restored sites.

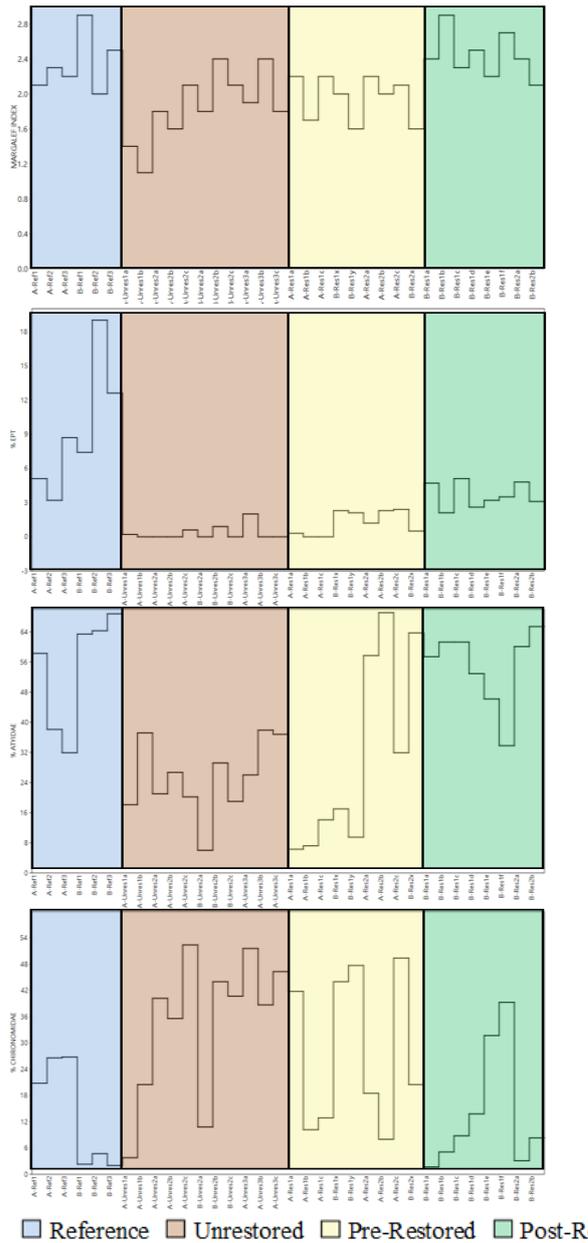
Figure 10. The steps graph of macroinvertebrate attributes in Surabaya River

The results of field survey on macroinvertebrate attributes are shown in Figure 13, and the results of multivariate Principal Component Analysis (PCA) is shown in Figure 10. There were 31 families of macroinvertebrate in Surabaya River showed high abundance of moderately sensitive taxa Atyidae and pollution tolerant taxa Corixidae, Chironomidae and Tubificidae. Some of macroinvertebrate specimen are shown in Figure 11.

The Mann Whitney U Test at 95% confidence shown that taxa richness and diversity index of macroinvertebrates increased significantly at post-restored sites compared to those at unrestored and pre-restored sites. The percentage of pollutant sensitive taxa EPT at post-restored sites was significantly different with those at unrestored and pre-restored sites.

The percentage of pollutant tolerant taxa Chironomidae at post-restored sites was significantly different with those at unrestored and pre-restored sites. The percentage of moderately sensitive taxa Atyidae at post-restored sites tend to increase and significantly different with those at unrestored sites. This was caused by improved bank stability and reduced bank steepness that increased percentage of vegetation cover on riverbanks thus provided more habitats for sensitive taxa and protected macroinvertebrate colony from washed away by high flow, to refuge under boulders and logs or attached on water plants roots and leaves.

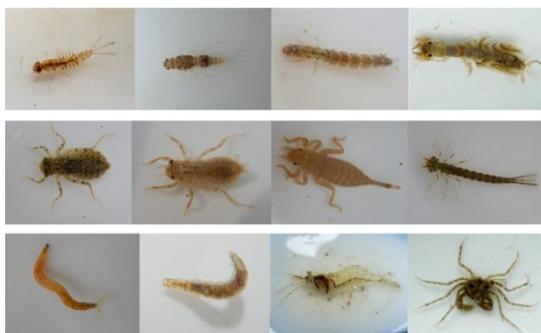
Figure 11. Macroinvertebrate specimen that were found in Surabaya River

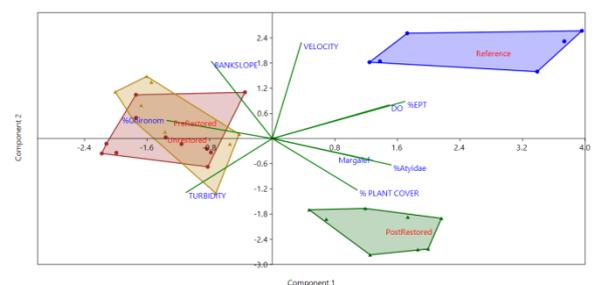
Figure 12. PCA Multivariate analysis on habitat parameters and macroinvertebrate attributes in Surabaya River

The reference group laid at upper right quadran, the post-restored group laid at lower right quadran, and the unrestored laid through pre-restored at middle left quadran. The important parameters at reference sites were near-bank velocity, Dissolved Oxygen (DO) and %EPT. Those parameters at reference sites are

significantly higher compared to other groups. Dissolved oxygen was strongly correlated with % EPT. The important parameters at post-restored sites are % littoral plant cover, Margalef's richness index and % Atyidae. Those parameters in post-restored sites are significantly higher than other group sites.

The important parameters at unrestored and pre-restored sites are bank slope, turbidity and % Chironomidae. This results suggest that ecohydraulic bank stabilization at post-restored sites changed the bank morphology and macroinvertebrate community, it given effects on bank morphology improvement and supported macroinvertebrate replenishment in littoral zone of riparian habitat in Surabaya River Fishery Sanctuary Area, as indicated by increased of % littoral plant cover, increased of Margalef's richness index and % moderately pollution sensitive taxa Atyidae or fresh water shrimp.

The Principal Component Analysis (PCA) was applied to identify the most important hydraulic and habitat components that correlated with macroinvertebrate attributes. The results shown that there were 3 groups of sample distribution that complement with research sites groupings as shown in Figure 12.
